Customer Testimonial

Almagard® Vari-Purpose Lubricant (3751)

Major Mine Operation – Central Montana

Primary Crusher

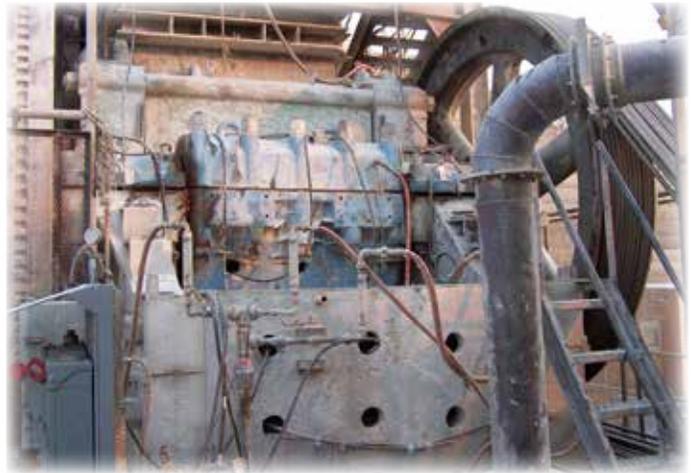
They operate a primary crusher. It is an older model jaw crusher that has Babbitt bearings. As you can see by the pictures this is no ordinary jaw crusher; it is very large. There are 16 points of lubrication on the main bearing housing.

Primary crusher bearing housing

After spending a lot of time researching the problems with LE's technical services manager, and asking questions of several of his peers, a solution began to emerge. Multiple recommendations were made. The piping, lines and fittings all needed to be bigger to keep the grease from being restricted. A different type of lubricant and delivery system needed to be used as well. Early in Spring 2007, the mine began replacing all of its 1 inch pipe in favor of 2 inch 10k psi pipe. They eliminated all the 3000 psi hydraulic line for 5000 psi line. They changed all their fittings to 3/8 from 1/4". The single farval system remained, but plans to add another system is on their way. Last but not least Almagard® Vari-Purpose

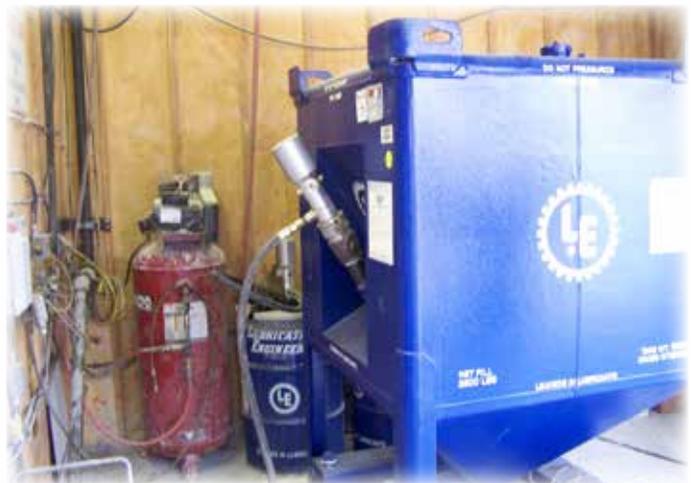
Lubricant (3751) was installed via a steel tote. A Liquidynamics air operated grease pump specifically designed for totes was installed (mdl 11396 as shown in picture).

Grease tote setup
