Des-Case LE-4 Breathers

Large PVC Manufacturing Plant in Central Georgia

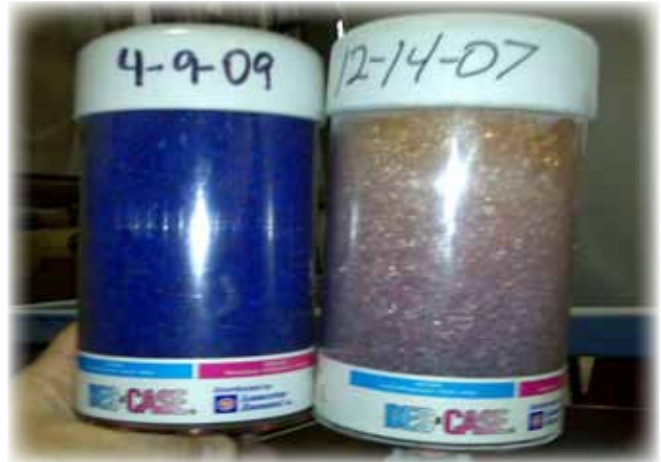
16 months of protection

the amount of ambient moisture in the environment in which they are operating. Look at the photos above, these breathers lasted 16 months and 15 months. Only four plugs were removed from the bottom of the breather.

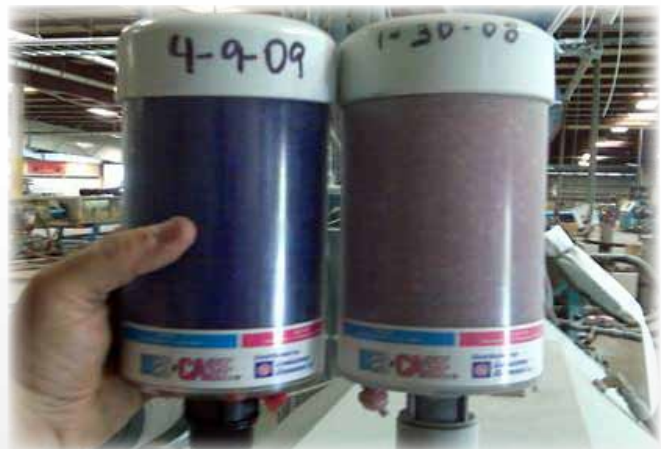
15 months of protection
