## Esco Oil Sight Glass Levelers & AMS Quick Connects

*Cup Manufacturing Company in the Southeast U.S.*

### *Cone Drive Gearbox*

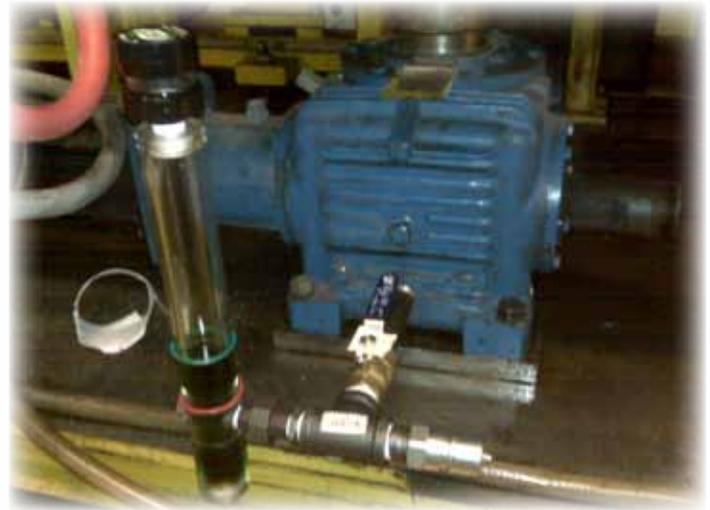
In addition, Mark recommended that the manufacturer install Quick Connects from AMS Filtration directly to

the gearbox drain ports to make oil drains easier. He suggested that the operator simply attach the hose from an existing filter cart to the AMS Quick Connect whenever the oil needed to be drained, then use the cart as a convenient transfer unit to get rid of the used oil.
